January 14, 2022

PND 222019

Re: Yakutat High School Roof Snow Load Assessment
Structural Engineering Report

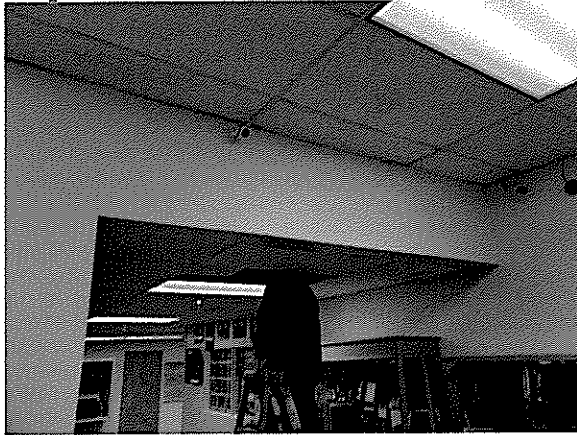
- 2) There is cracking in finishes at the lobby/hallway adjacent to the superintendent's office and in the receptionist office. The damage is not a structural concern, but is evident even under low to moderate load on the roof as structural framing deflects.

Ceiling transition at High School Lobby/Corridor has cracks on each end: Roof trusses are not supported by this but when they are moderately loaded the trusses push this 2x framed box beam down and the gypsum wall board cracks

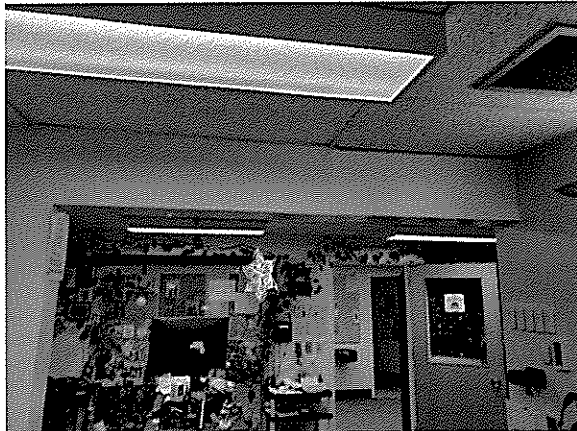
False Header in Receptionist Office: Not a structural member and can be removed. This is pushed down when roof trusses are moderately loaded

- 4) Remove the false header at the reception room. There is a gypsum wall board finished, 2x4 framed, false header below the suspended acoustical ceiling. It is an aesthetic feature that has no structural value. It is moved and loaded when roof framing above deflects. It is not structural and it unnecessarily causes concern when roofs are loaded with a moderate load (below the snow design load).

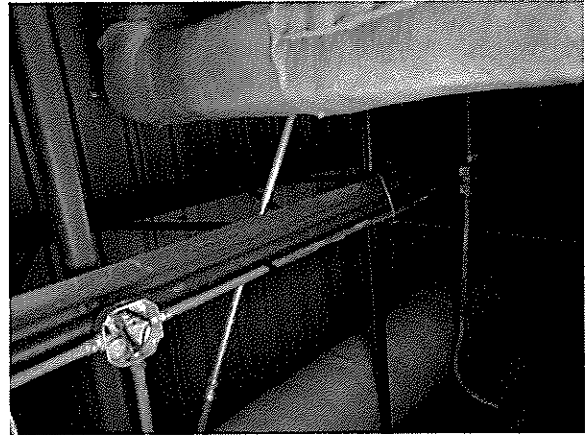
- 3) There are bent web members in a steel joist over the receptionist office. It is not known whether these were caused by excessive snow loads or were damaged during construction and have not been noticed until this inspection.

Roof joist above Receptionist Office with bent web members.

- 5) The steel joist with bent web members should be repaired. Either the bent sections of the diagonal web be heated and then mechanically pushed into a relatively straight condition or new additional bars be welded either side of the bent section and welded to the top and bottom cord. The bending to straight alternative should only be done by a person experienced in that type of work. Welding additional pieces should be done by an experienced welder with certification to perform fillet welds. The paint at the weld area needs to be removed by grinding. Place a 5/8 inch diameter bar on each side and parallel to the bent member then weld each end with a 1/4 inch flared bevel weld on each side of the bar. The bars should be bare steel or have their paint removed at the weld area.

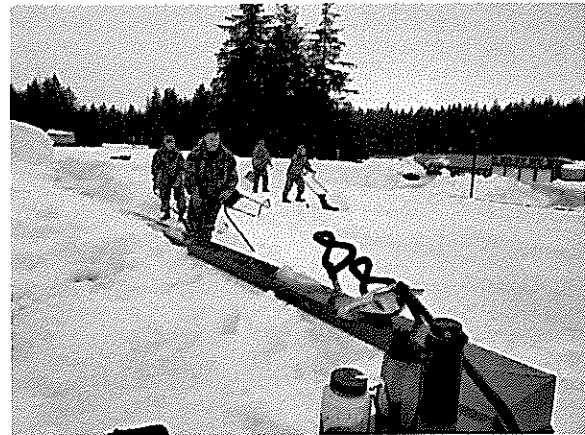
Snow removal at Elementary School, south side of building. 4 feet of depth was measured.

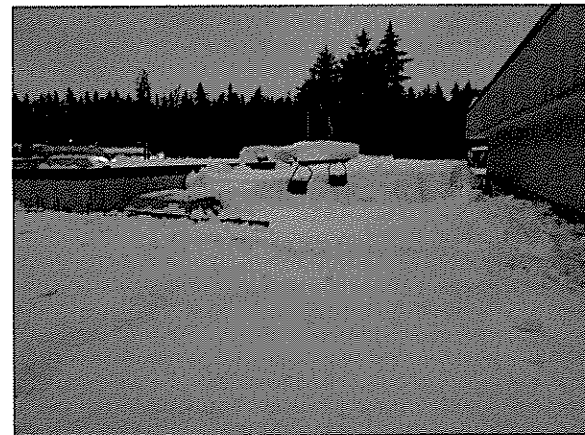
Extent of snow removal over main entry of High School. Depth similar to Elementary School.

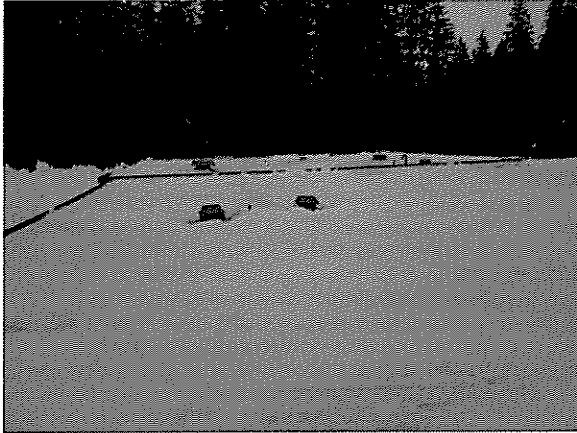
Snow mostly removed from east side of High School
